MILLABRADING TEST EVALUATION

**Norwood Road – M.P. 287.02
(Southbound Interstate 5)**

Construction Report

FHWA-OR-RD-00-02

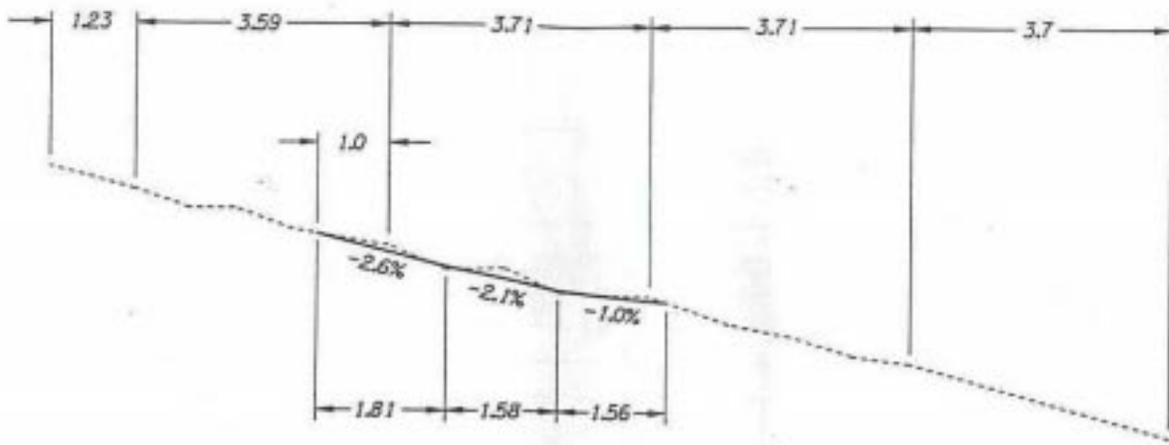
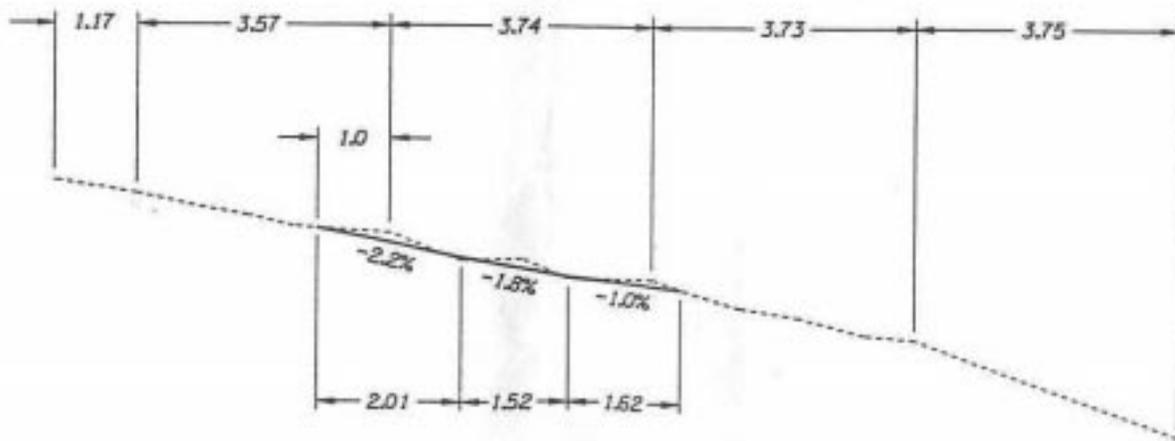
Figure 2.3: Design Cross Sections

The design cross sections are shown in Figure 2.3. A minimum cross slope of 1% was set to maintain drainage. A maximum cross slope of 3% was allowed. Approximately 16 mm of PCC pavement would be removed. Project monitoring included identifying any impacts associated with creating a broken slope in the middle lane. Would the different slopes affect automobile handling and/or increase accident frequency?

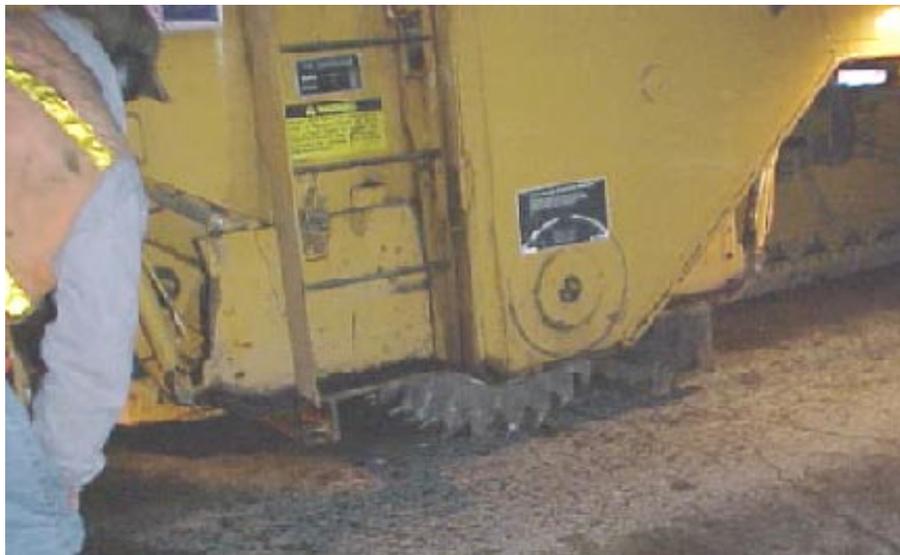
Figure 3.1: Modified Rotomill Drum

The milling process utilized a rotomill built by CMI out of Oklahoma City, model PR-800-7. The machine weighed 33.6 Mg and operated at 597 kW. Modifications to the unit included a modified drum speed, automated grade control skis, and a custom built drum. MillCo, also out of Oklahoma City, manufactured the drum. The 2.1 m wide drum provided a tooth spacing of 4.5 mm (*Halton 1999*). The rotomill is reported to operate at about 6 m/min over a 2.1-m wide path. Based on discussions with the contractor, machine weight and drum speed, along with tooth spacing were found to be critical to the effectiveness of the milling. Figure 3.1 includes a photograph of the modified drum.

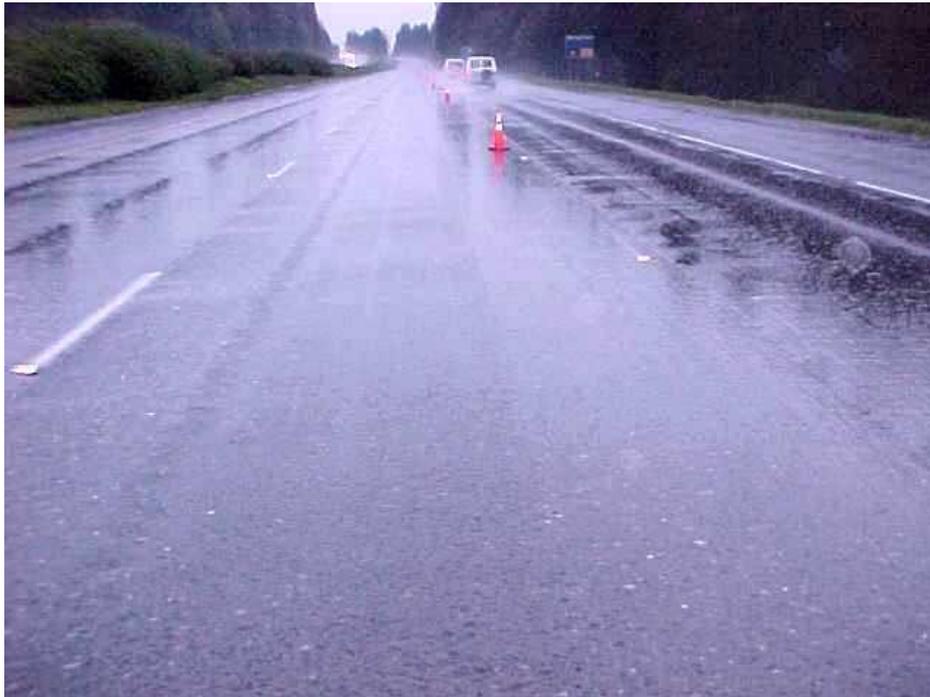
Figure 4.1: Post Construction Pavement Looking South (4/10/99)

Based on discussions with ODOT District Maintenance personnel, the millabraded section appears to be performing adequately. No problems with drainage have been noted. Following construction, there are still ruts in all the wheel paths, however, even with the change in the cross slopes, no drainage problems have been noted.

The test section was inspected on April 10, 1999. The local maintenance office provided a two-lane closure so that the middle and fast lanes could be inspected. Random rut measurements using a rut bar varied from 10 to 16 mm in the middle lane. Some remaining rut depth was expected based on the project design, however, not to the degree measured. The greater rut depths may have been due to insufficient pre-construction survey data used for the design. Figure 4.1 shows the middle lane pavement appearance looking south.

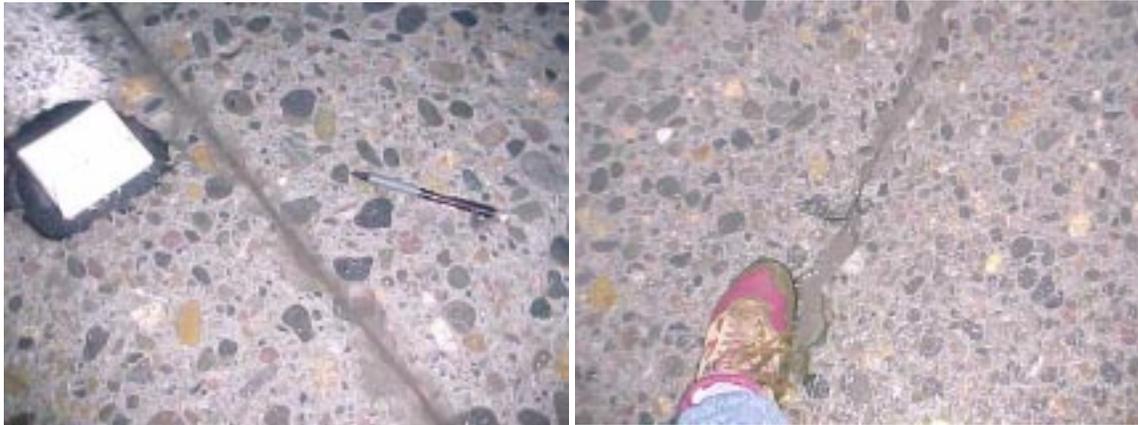
Figure 4.2: Low Severity Spalling at Construction Joint (4/10/99)

The sawcut joint between the fast and middle lane appeared more spalled than the construction joint between the middle and truck lane. The spalling noted for both longitudinal joints would be classified as low severity as defined by the *SHRP Distress Identification Manual for the Long-Term Pavement Performance Project (SHRP 1993)*, however, it was more apparent than before milling. Figure 4.2 shows the spalling observed between the fast and middle lane sawcut joint at two locations.

Also noted during the post construction inspection, the longitudinal joints appeared spalled. A petrographic analysis indicated that there is no micro-cracking that may be detrimental to the durability of the section. Accident data for comparison between the before and after conditions is not currently available, therefore, assessments of the traffic impacts attributable to the broken slope in the middle lane are currently unknown. District maintenance staff report no problems with the section.

- Crack filling using proprietary filler or other slurry type material should be investigated to reduce spalling of longitudinal joints.
- Millabrading specifications need to specify the machine weight and tooth spacing as shown in the test project's Special Provisions. Both factors are critical to the project outcome. Future projects should also specify a production rate, shown to minimize potential aggregate popout and spalling.

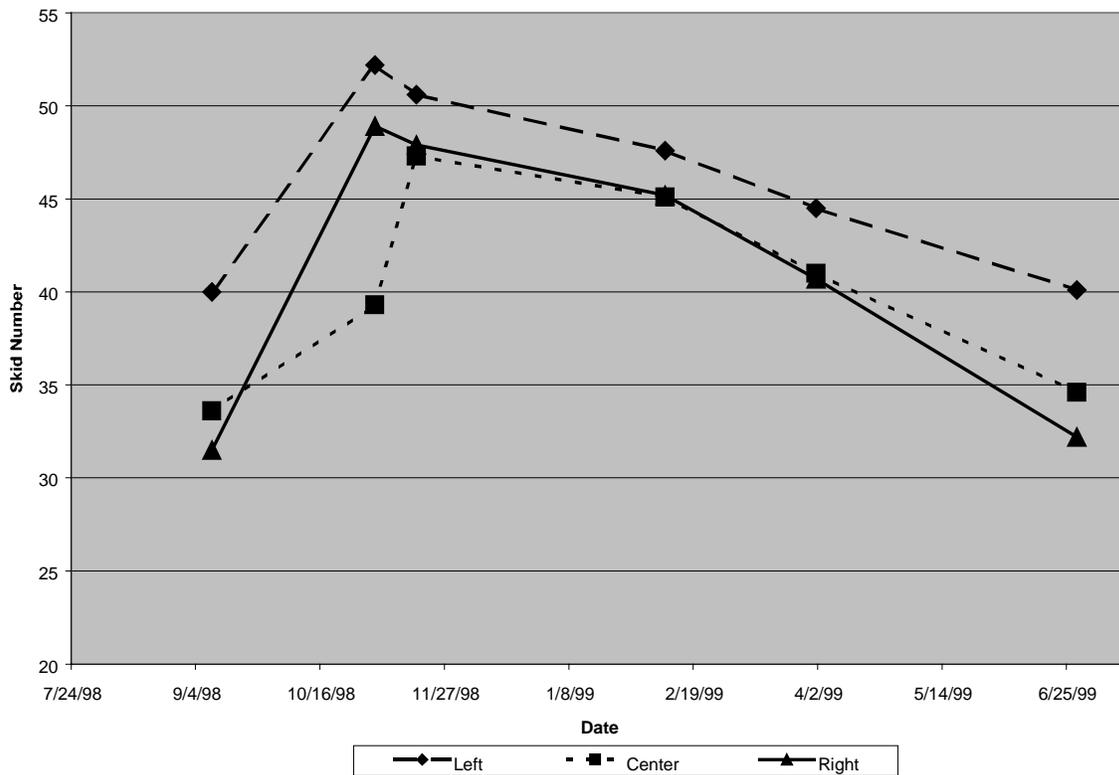
Figure 4.3: Friction Testing Results

All friction testing was done at speeds near 64 km/hr in the left wheel path of all three lanes using a K.J. Law trailer. The data from the tests were converted to standard 64 km/hr friction numbers using correlation equations. Skid testing was performed before the milling and then several times after project completion. One skid test was done after the milling but prior to the shot blasting in the middle lane. The average skid numbers for the three lanes are shown in Figure 4.3.

The November 3, 1998 friction testing includes results for shot blasted sections (fast and slow lanes) and a section with only milling (center lane). The milling increased the skid number from 34 to 39 in the center lane. With the shot blasting, the center lane skid number increased from 39 to 47. Skid numbers, however, have continued to decline, returning to near the preconstruction skid numbers.

- The need for the shot blasting should be further investigated. Shot blasting is primarily necessary for cleaning the surface, reducing the micro-cracking, and increasing skid resistance. It is not known whether additional sweeping could clean the surface or if micro-cracking is a significant issue. The benefits of improved skid resistance from the shot blasting appear to be short term.
